STEVENS PAPER COMPANY (UPPER) DAM
MA-00075

NATIONAL DAM INSPECTION PROGRAM
CORPS OF ENGINEERS

4. TITLE (and Subtitle) Stevens Paper Company (Upper) Dam NATIONAL PROGRAM FOR INSPECTION OF NON-FEDERAL DAMS		5. TYPE OF REPORT & PERIOD COVERED INSPECTION REPORT

June 21, 1979

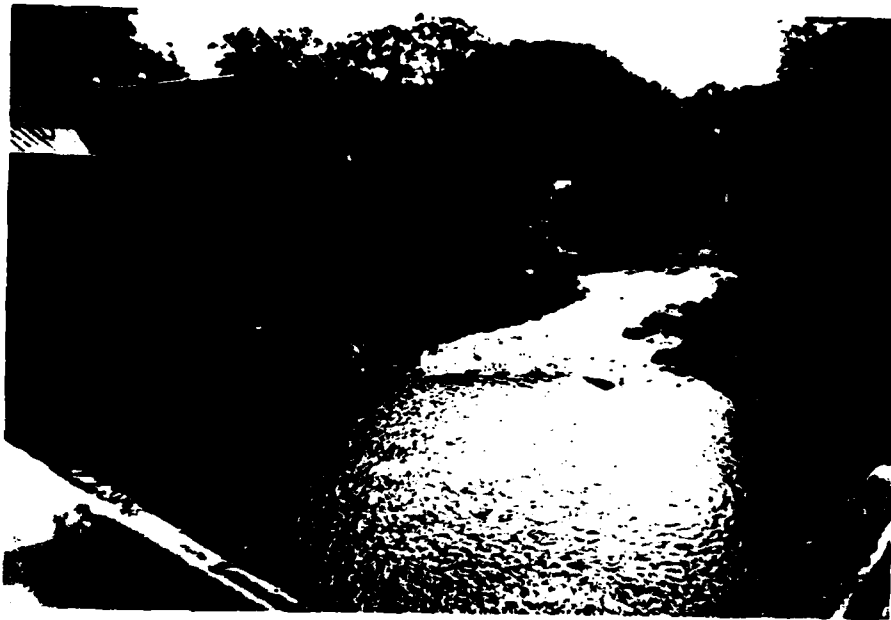
3. Downstream channel from right abutment.

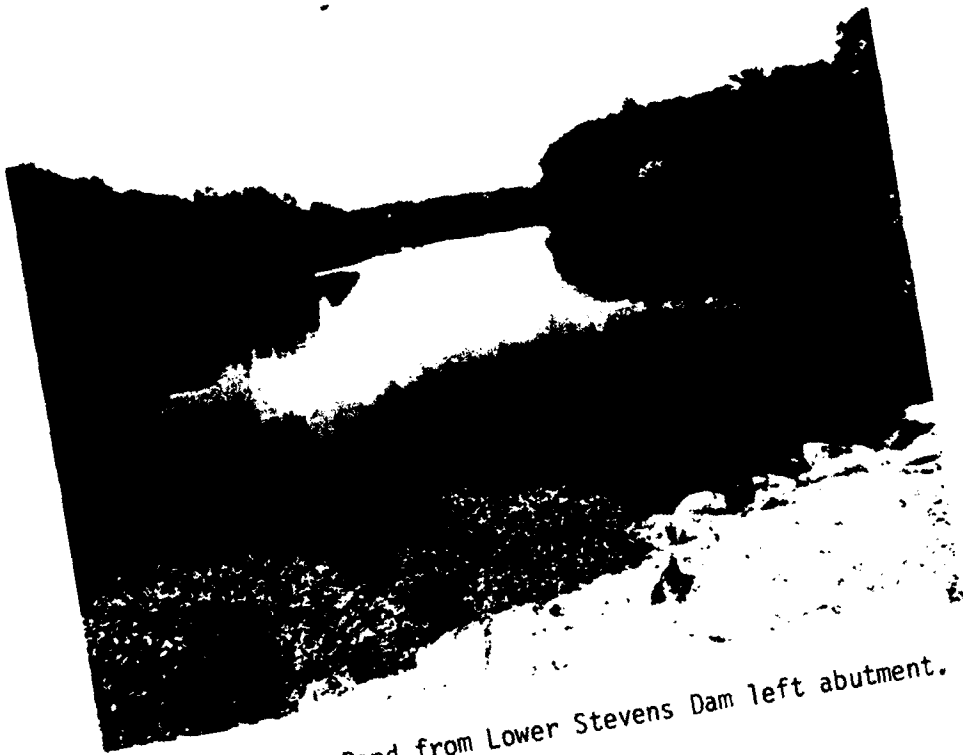
According to the FIS Flood Boundary Maps, no developed areas are affected by the 100-year flood between the Upper and Lower Stevens Co. Dams, a reach length of 1.3 miles. Crane Pond is formed by the Lower Stevens Co. Dam and would experience a surge as a result of a failure of the Upper Stevens Dam. However, assuming no reduction in the failure outflow in the 1.3 mile reach, a 5 foot freeboard would remain at the lower dam. Downstream of the Lower Stevens Dam is an extensive, underdeveloped flood plain which would attenuate any surge which might pass through Crane Pond.

7. View of Crane Pond from Lower Stevens Dam left abutment.

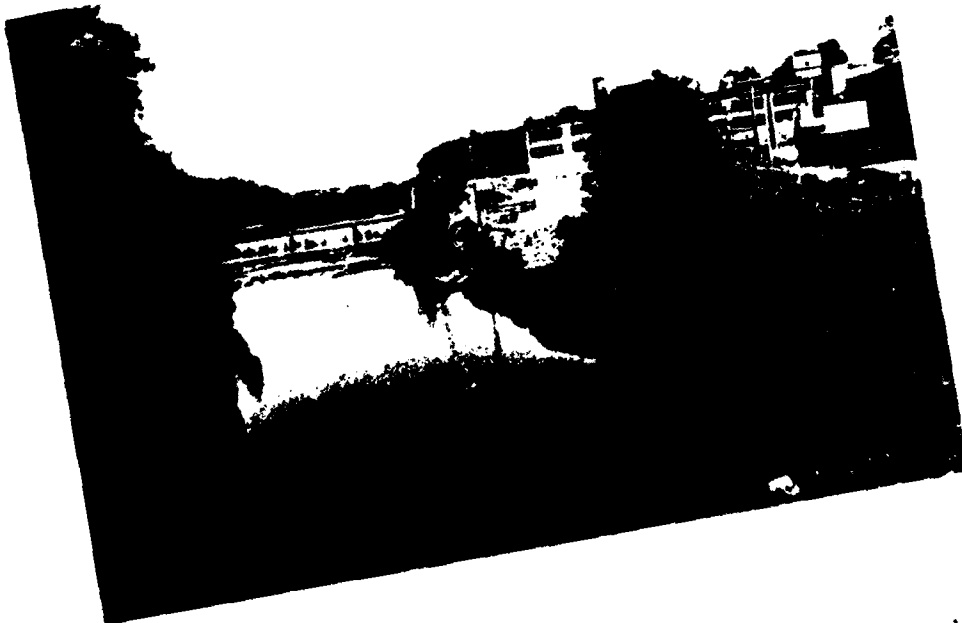
8. View of Lower Stevens Dam and adjacent mill from Southwick Road Bridge.

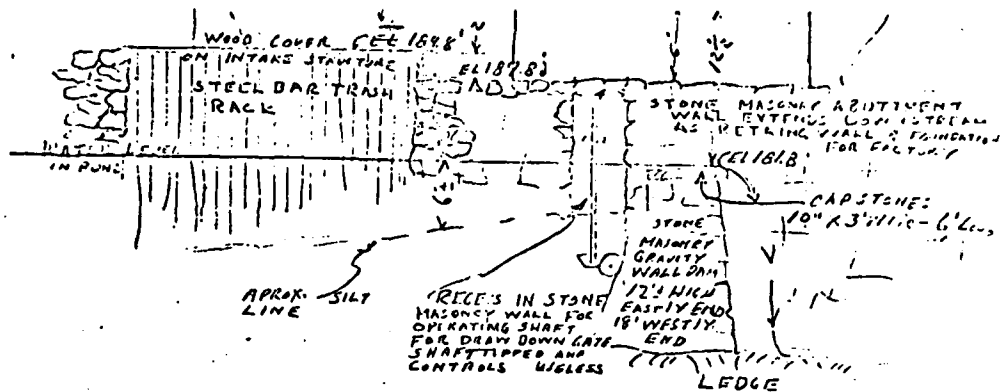
X SECTION A A - SHOWING EAST ABUTMENT
& INTAKE FOR MILL

According to the Mill Maintenance Supervisor the control at the penstock inlet has not been operated for some time but control valves and gates inside the Mill are operating. The penstock entry chamber is covered with a plank deck with the hand wheel controlling the intake gate projecting above it. Close inspection of the intake was not practical. There is a steel bar trash rack on the river side of the entry chamber.

In 1957 a concrete flood training wall was built on top of the old stone abutment wall on the northeasterly end of the dam with a leg extending into the slope to prevent flooding of the Mill and Mill Yard. At this time the shaft for the remote control for the drawdown gate in a recess in the abutment wall was forced outward making it inoperative. The concrete wall and stone masonry abutment are in good condition.

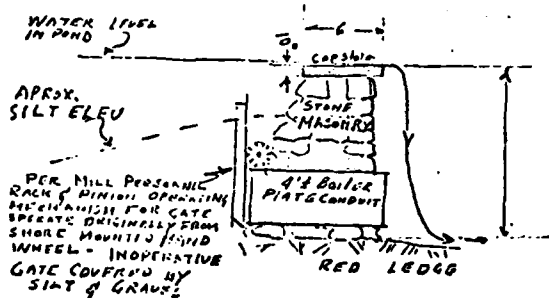
X SECTION BB - THRU 4" x 4" DRAWDOWN
CONDUIT - 10' FROM EAST
END DAM

Clogged or Blocked Spillway Drawdown gate inoperative and covered with silt, sand and gravel by floods.

The old four foot diameter drawdown conduit through the base of the stone masonry spillway wall about ten feet from the east end was visible on the downstream face. Silt and other debris covered the upstream end and the gate. The Plant Maintenance Supervisor said that the gate was originally operated by a rack and pinion arrangement located under the water at the gate. The pinion was turned by means of a hand wheel located on the abutment through a system of gears. This drawdown has not been opened for years and the operating mechanism is inoperative.

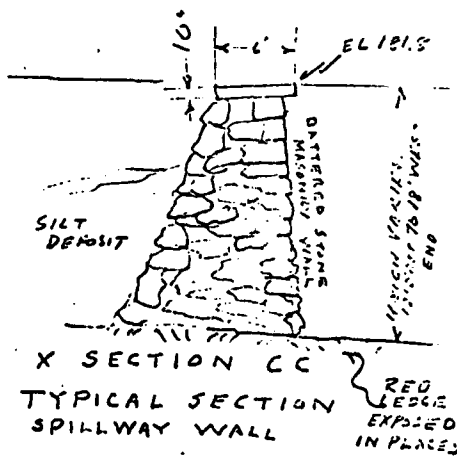
X SECTION CC
TYPICAL SECTION
SPILLWAY WALL

The alignment and grade of spillway structure and the abutments were true with no visible sags or bulges and no loose or missing stones noted. It appears to be built on red sand stone ledge.
